## JUST BLOWING SMOKE... the right way

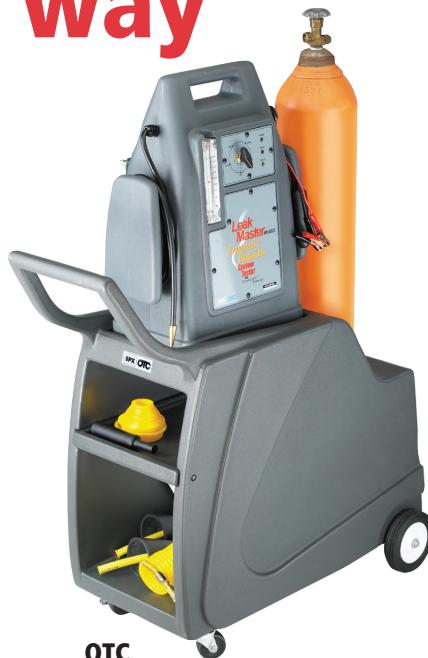
**OTC  
LeakMaster**

OTC DAT (Digital Automotive Tester) to get BAT voltage. I also applied vacuum to the vacuum hose coming from the engine to the LDP until the reed switch wire circuit opened, indicating Vent Closed. The system was then in TEST mode, ready for the big gun—the OTC LeakMaster 6525.

The tester was calibrated for a .020” leak because, and this is key, by code definition we weren’t looking for a LARGE leak, but one the thickness of a few strands of hair. Knowing that the EVAP system was now closed off, I took the OTC LeakMaster 6525 to the test port of the car and turned it to TEST. It started to pressurize the LDP system up to 13 inches of water column (about 1/2 psi). In less than two minutes, the ball in the meter showed the leak to be just a bit larger than .020”. Then, I rotated the selector valve to

SMOKE. Within 45 seconds, smoke appeared from the back corner of the mini-van. Total diagnostic time? Less than 20 minutes start to finish, and the UV dye helped me “see” the leak coming from the top of the tank. So, I knew right away where the leak was, and that the tank needed to be pulled. That, my friend is not just blowing smoke, THAT’S BLOWING SMOKE AND MAKING MONEY!

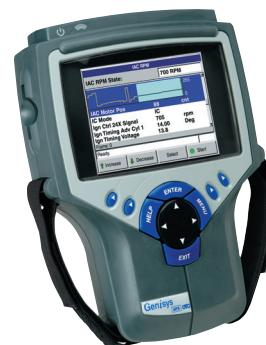
**Genisys**

Case in point. Our customer’s 2001 Chrysler Town and Country minivan had a problem that’s common: the “Check Engine” light was on. Since we sold “Scan for codes” as part of the diagnostic procedure, out came my trusty OTC Genisys scan tool. Tapping into the vehicle’s PCM turned up a P0456, code for a very small leak in the EVAP system. Most shops seem to think that just tightening the gas cap will fix this EVERY time. We knew better. We just bought a new OTC LeakMaster 6525 EVAP approved “smoke machine” with UV Dye AND taken the time to learn how it differed from our older machine. What we found is that it really helps cut diagnostic time and increase accuracy. Here’s what happened.

The minivan had a Leak Detection Pump (LDP) EVAP system. Reviewing a printout of the related wiring told me the LDP had three wires: a power wire, a solenoid ground wire and a reed switch wire. Using the Genisys tool, I went to “Special Tests,” then to “Actuator Tests” to do the “LDP Systems Test”. Now I could activate the LDP vent solenoid that I had commanded closed. I monitored the reed switch wire with my
